**NOTICE OF NON-COMPLIANCE**

**RE: Hazardous Waste Compliance Inspection, Boehringer Ingelheim Vetmedica, Inc.,  
KSD067925347, Doniphan County, Kansas**

# HAZARDOUS WASTE GENERATOR COMPLIANCE INSPECTION CHECKLIST

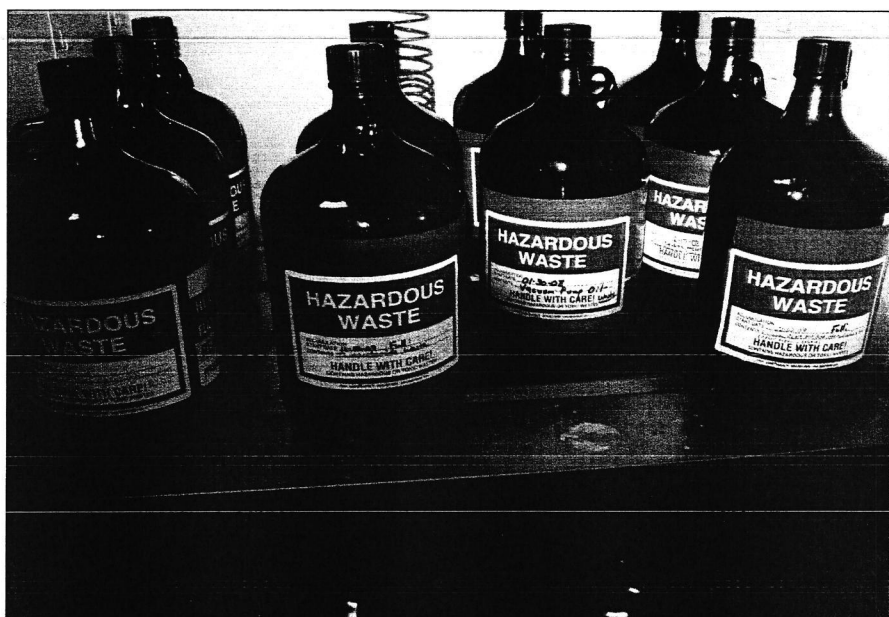
Picture No.:	<u>3</u>
Archive Disc File No.:	<u>IMG_0168</u>
Date:	<u>December 30, 2008</u>
Time:	<u>2:09</u>
Location:	<u>QC Lab Storage Area</u>
Direction Faced:	<u>East</u>
Weather Conditions:	<u>Indoor</u>
Comments:	<u>Middle shelf from Photo 1.</u>

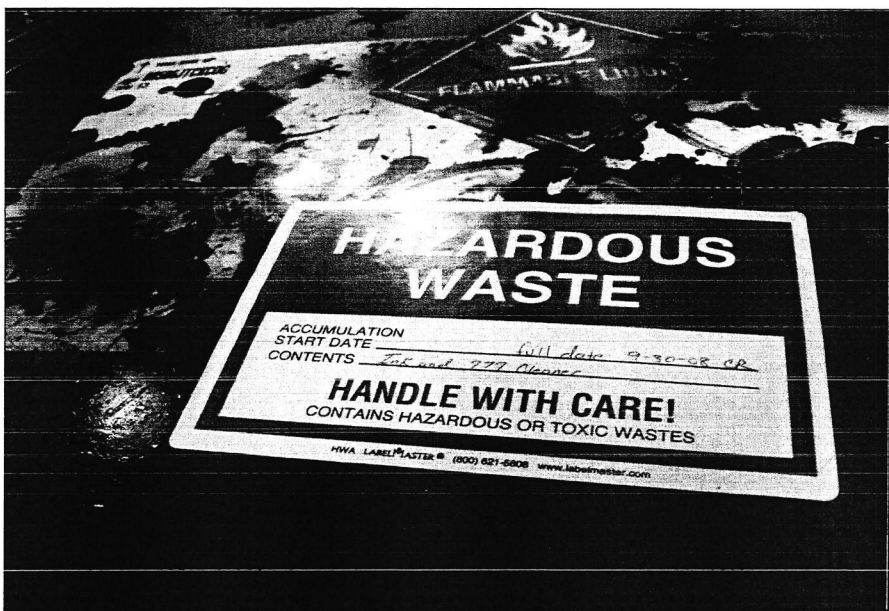
- A) *One 55-gallon drum of waste ink and 777 cleaner in Building H with an accumulation start date of September 30, 2008.*
- B) *One 55-gallon drum of non-halogenated solvent in Building H with an accumulation start date of September 29, 2008.*

Picture No.:	<u>4</u>
Archive Disc File No.:	<u>IMG_0150</u>
Date:	<u>December 30, 2008</u>
Time:	<u>12:19</u>
Location:	<u>Building H</u>
Direction Faced:	<u>West</u>
Weather Conditions:	<u>Indoor</u>
Comments:	<u>Container of Waste Ink and 777 Cleaner with an accumulation start date of September 30, 2008.</u>

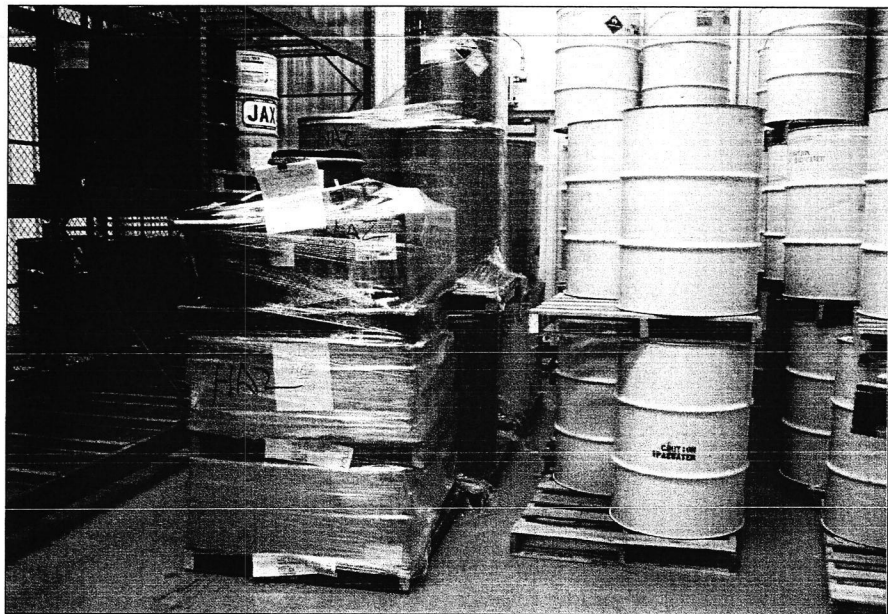
*On the day of inspection, there was inadequate aisle space in Building H to properly manage hazardous waste.*

Picture No.:	9
Archive Disc File No.:	IMG_0143
Date:	December 30, 2008
Time:	12:07
Location:	Building H
Direction Faced:	North
Weather Conditions:	Indoor
Comments:	The two pallets of cardboard boxes in the front left stack, labeled "HAZ" contained 56 boxes of 48 500 mL vials of Metacam. The boxes were not labeled with the words "hazardous waste" or the accumulation start date. The containers on the top pallet above the Metacam are described in photos 11 & 12. The 40-gallon fiber containers contained anthelmintic waste. The light blue drums contained waste IPA and water or were empty. Notice the insufficient aisle space between the stacks of waste.

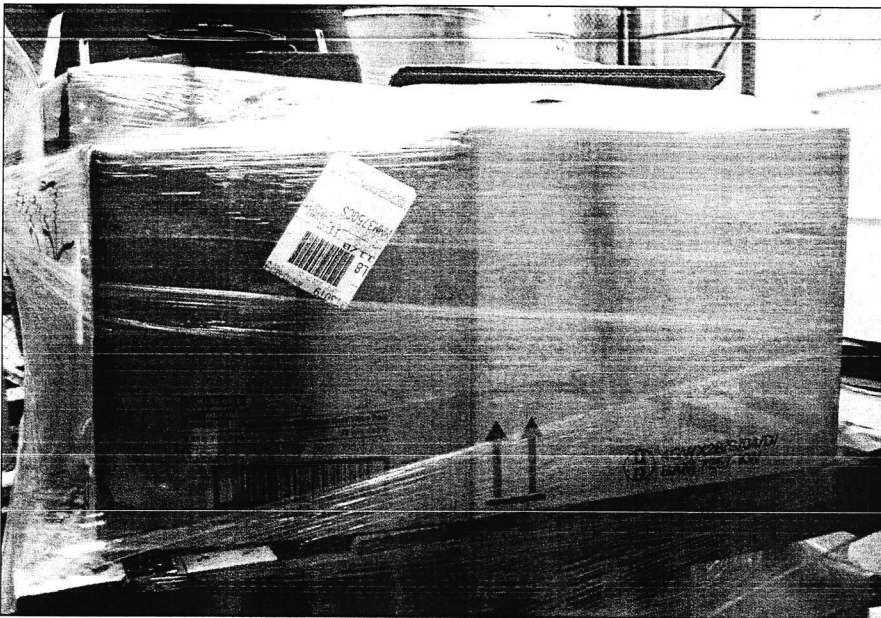
Picture No.:	11
Archive Disc File No.:	IMG_0161
Date:	December 30, 2008
Time:	1:08
Location:	Building H
Direction Faced:	West
Weather Conditions:	Indoor
Comments:	Two boxes of Blue Lotion aerosol cans not labeled with the words "hazardous waste" or the accumulation start date. The blue 10-gallon poly container behind the boxes contained waste phenol crystal and was not labeled with the words "hazardous waste" or the accumulation start date.

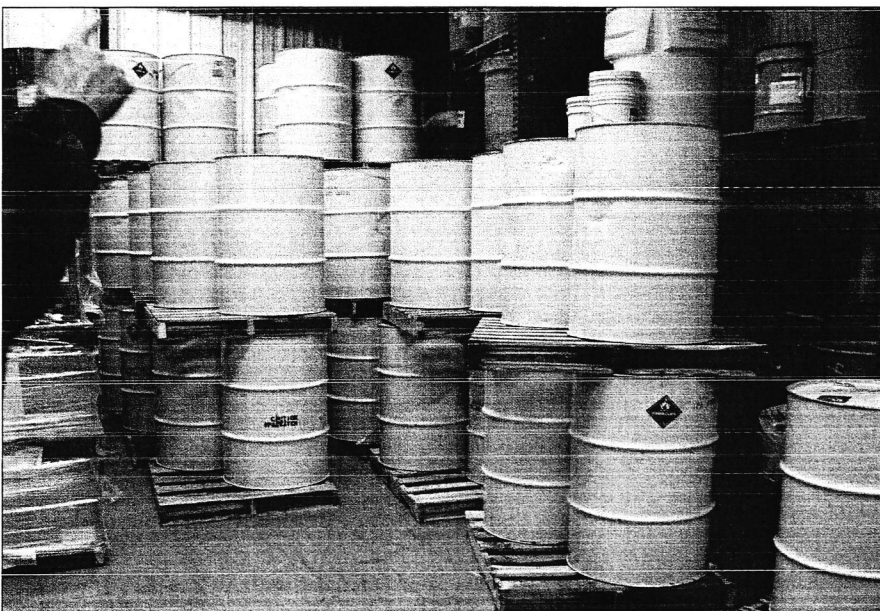
**Picture No.:** 14  
**Archive Disc File No.:** IMG\_0142  
**Date:** December 30, 2008  
**Time:** 12:07  
**Location:** Building H  
**Direction Faced:** North  
**Weather Conditions:** Indoor  
**Comments:**  
This photo shows the insufficient aisle space in the hazardous waste storage area. I was unable to fit between the stacks of waste to inspect the containers. The pallets had to be moved so I could read the hazardous waste labels on the top of the drums. The light blue 55-gallon drums are waste IPA and water or empty. The containers on the racks to the right were empty or contained spill control material.

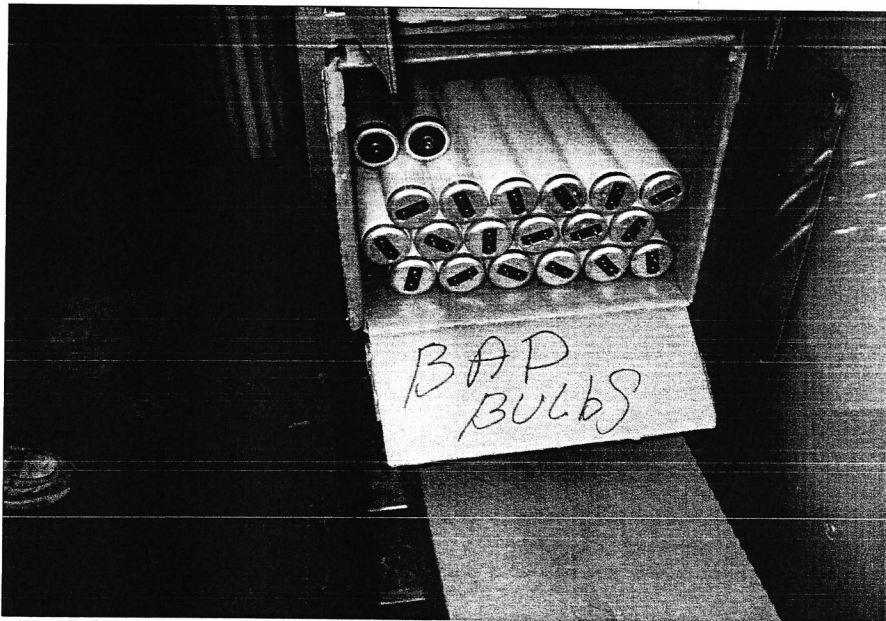
Picture No.:	19
Archive Disc File No.:	IMG_0173
Date:	December 30, 2008
Time:	2:41
Location:	Maintenance Utility's Room
Direction Faced:	North
Weather Conditions:	Indoor
Comments:	Waste fluorescent lamps not properly labeled.
